SI98.00-P-0015A	Service Information: Painting bumpers with short range radar	18.8.15
-----------------	--	---------

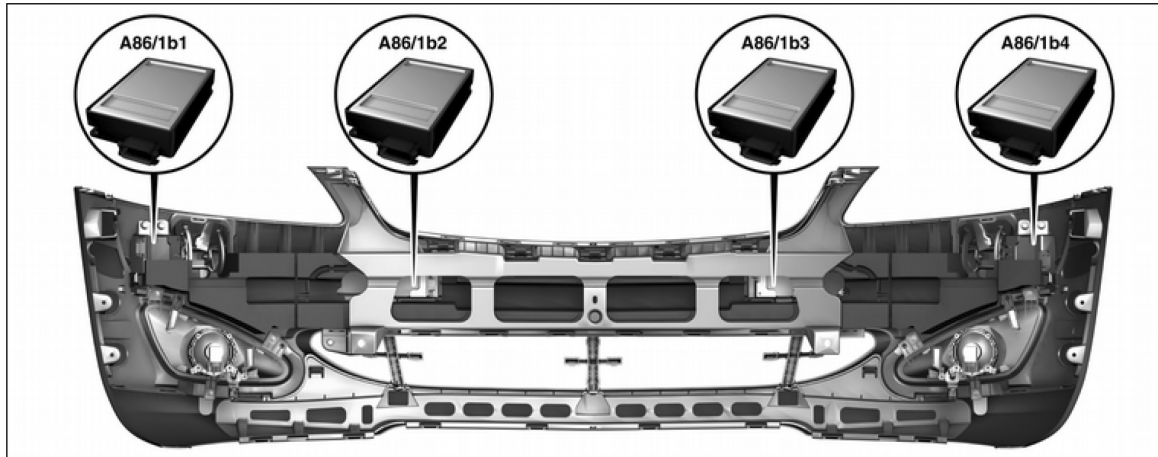
P30.30-2075-08

Location of radar sensors in front bumper, shown on model 221

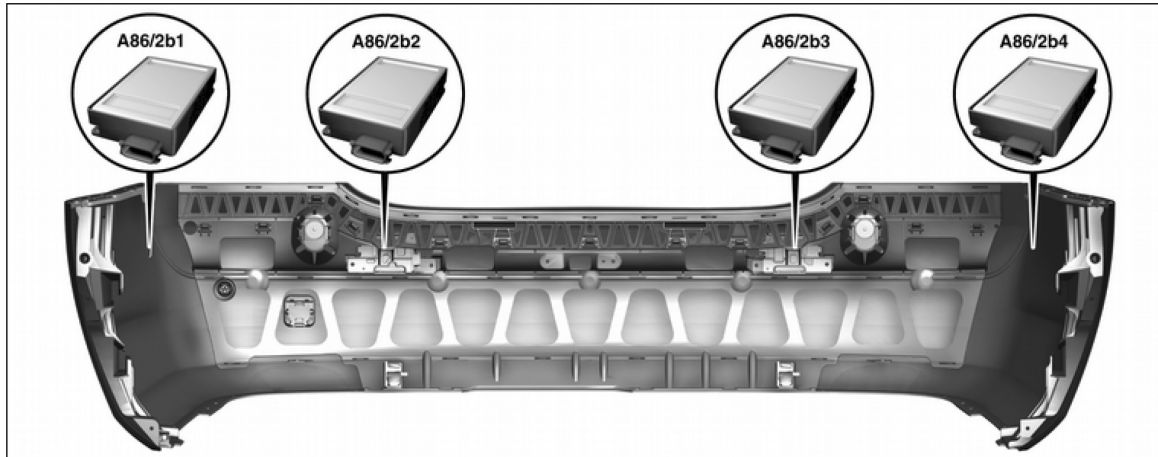
P30.30-2076-08

Location of radar sensors in rear bumper, shown on model 221
